**Flood Control Project Maintenance
Levee Inspections**
LMA District Cover Sheet
Spring 2019 Levee Inspection Results

Reclamation District No. 2063 Crows Landing

Spring 2019 Levee Inspection Results

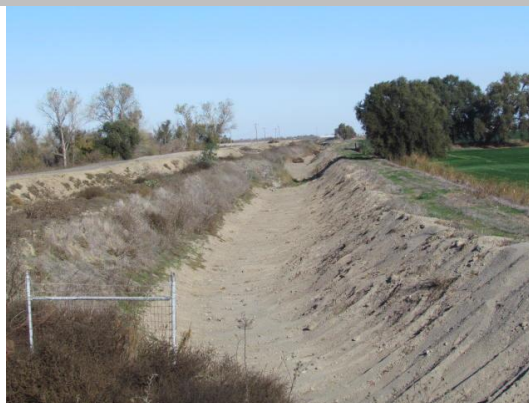
Photo 3 of 3 : SP_2019_RD2063_112_18_20190307_00003.jpg

Looking south at canal-ditch at landside berm and toe.

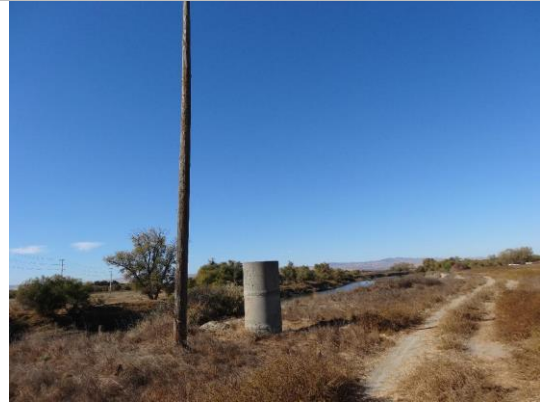
Photo 1 of 3 : UCIP_SP_2019_50216_43166.jpg

Comment Code						
Inspector Comment						
FS_ID:50216 DS_ID:22075 EP_NO: N/A Repair Type: Non-Urgent Crossing Status: Indicator Found UCIP Comments: 08/23/2016: Could not locate pipe during inspection, though it was very prominently visible on the WS bank and LS ditch as per 2013 photos. I confirmed with RD2063 president Joe Sallaberry that the pipe was filled with concrete through the levee but removed at the LS ditch. Could not locate pipe's ends during inspection. No permit exists for this work. Crossing has been downgraded from Urgent to Non-Urgent since we lack documentation verifying proper abandonment. (K. Fazel - DWR UCIP) 11/05/2013:- Pipe has visible holes throughout both and WS along with pipe deformation. - looks abandoned. Needs proper abandonment.- alfalfa valve on concrete pipe riser on waterside toe.- no slide gate found on waterside. No pump and pile structure found in river. (P. Amatya - DWR UCIP) FIELD_STRUCT_DESC: *ABANDONED* 24-inch corrugated metal irrigation discharge pipe through the levee, 10 feet below the crown, not found during 2016 inspection. Slide gate in a corrugated metal pipe (CMP) riser on the waterside (WS) slope, not found during 2016 inspection. Pipe supported on two timber pile bents across a drainage ditch on the landside (LS), only pile remnants found during 2016 inspection. Pump on a pile structure in the river, not found during 2016 inspection. Two concrete standpipes on the WS berm, one of which was found during the 2016 inspection. Installed by USACE in 1961. [Additional Reference(s): DWR Levee Log, 1992. USACE San Joaquin O&M Manual 6, September 1961, (HLM 1.29)]. FS Date: 8/23/2016

WS view: abandoned concrete standpipe and abandoned power pole.

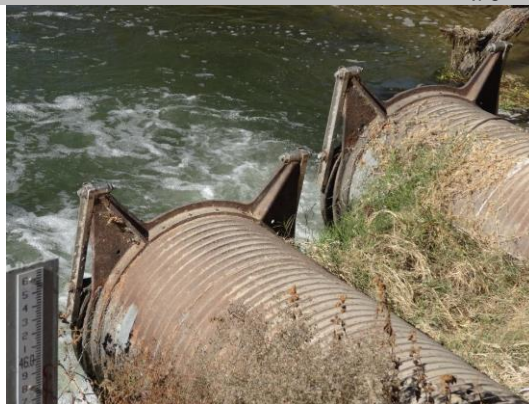
Photo 2 of 3 : UCIP_SP_2019_50217_43216.jpg

Comment Code					
Inspector Comment					
FS_ID:50217					
DS_ID:22119					
EP_NO: N/A					
Repair Type: No Action Needed					
Crossing Status: Found					
UCIP Comments: 08/23/2016: WS flapgates were held open by a piece of wood. Pipes may be used temporarily for irrigation. (K. Fazel - UCIP)11/05/2013: working during field inspection. (P. Amatya - DWR)					
FIELD_STRUCT_DESC: [Lateral Drain No. 5] 2 of 2: 48-inch corrugated metal gravity drainage pipe through the levee, 25.5 feet below the crown. Slide gate in a corrugated metal pipe (CMP) riser on the waterside (WS) slope. Flap gate on the WS end. 70-foot-long cobble spillway to river. Installed by USACE in 1961. [Additional Reference(s): DWR Levee Log, 1992. USACE San Joaquin O&M Manual 6, September 1961, (HLM 1.35)].					
FS Date: 11/5/2013

WS view: two CMP outfall pipes with flap gates on levee slope.

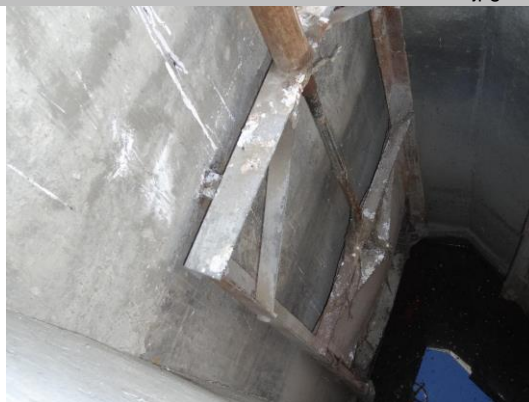
Photo 3 of 3 : UCIP_SP_2019_51823_43346.jpg

Comment Code						
Inspector Comment						
FS_ID:51823						
DS_ID:22081						
EP_NO: N/A						
Repair Type: No Action Needed						
Crossing Status: Found						
UCIP Comments: 11/05/2013 - concrete standpipe on waterside toe.- concrete distribution box on landside.- an alfalfa valve on waterside toe. (P. Amatya - DWR UCIP)						
FIELD_STRUCT_DESC: 30-inch corrugated metal gravity drainage pipe through the levee, 12 feet below the crown. Flap gate on the waterside (WS) end. Slide gate in a concrete distribution box on the landside (LS) end. Concrete U-shaped headwall on the WS end. [Additional Reference(s): DWR Levee Log, 1992. USACE San Joaquin O&M Manual 6, September 1961, (HLM 2.29)].						
FS Date: 11/5/2013

LS view: slide gate in concrete distribution box.

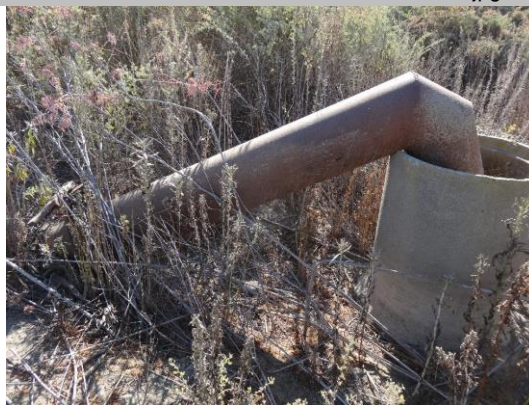
Photo 3 of 3 : UCIP_SP_2019_24427_43437.jpg

Comment Code						
Inspector Comment						
FS_ID:24427 DS_ID:22085 EP_NO: N/A Repair Type: Non-Urgent Crossing Status: Found UCIP Comments: 11/05/2013 Abandoned steel pipe and service pole on waterside. Pump not found on river bank. CMP riser on waterside slope. Slide gate not found in CMP riser. Steel pipe riser on waterside berm.Damaged PVC standpipe on waterside slope. (P. Amatya - DWR UCIP) FIELD_STRUCT_DESC: *ABANDONED* 24-inch corrugated metal irrigation discharge pipe through the levee, 10 feet below the crown. Slide gate in a corrugated metal pipe (CMP) riser on the waterside (WS) slope. 20-inch standpipe 3 feet from the landside (LS) toe. 12-inch pipe across the berm and into a CMP riser on the WS slope. Pump on riverbank. Installed by USACE in 1961. [Additional Reference(s): DWR Levee Log, 1992. USACE San Joaquin O&M Manual 6, September 1961, (HLM 2.46)]. FS Date: 11/5/2013

WS view: steel pipe and concrete riser on levee berm.

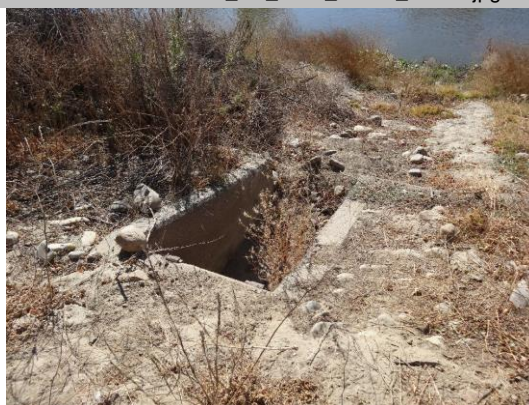
Photo 1 of 3 : UCIP_SP_2019_24435_43484.jpg

LM Start	2.62	Rating **	M	Issue No.	65
LM End	2.62	Issue Type +	Ma	Location *	
Category	Supplemental			GPS Latitude/Longitude	
				Start	End
Item	DWR UCIP LMA Responsibility			37.448233 °	37.448233 °
				-121.026521 °	-121.026521 °
DWR ID	22086				
Comment Code					
Inspector Comment					
FS_ID:24435 DS_ID:22086 EP_NO: N/A Repair Type: Non-Urgent Crossing Status: Found UCIP Comments: 11/05/2013 Both pipe ends 70 ft off the levee center.Clearing and cleaning of inlet/outlet pipe needed. (P. Amatya - DWR UCIP) FIELD_STRUCT_DESC: 24-inch corrugated metal gravity drainage pipe through the levee, 12 feet below the crown. Flap gate on the waterside (WS) end. Concrete headwall on each end. Installed by USACE in 1961. [Additional Reference(s): DWR Levee Log, 1992. USACE San Joaquin O&M Manual 6, September 1961, (HLM 2.65)]. FS Date: 11/5/2013

WS view: U shaped headwall outlet structure 70 ft off the levee center.

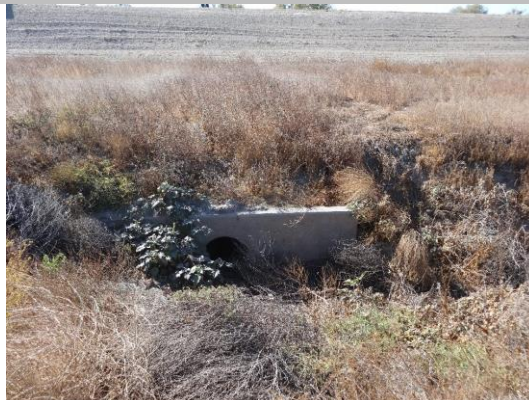
Photo 3 of 3 : UCIP_SP_2019_24435_43482.jpg

LM Start	2.62	Rating **	M	Issue No.	65 (cont)	
LM End	2.62	Issue Type +	Ma	Location *		
Category	Supplemental			GPS Latitude/Longitude		
				Start		End
Item	DWR UCIP LMA Responsibility			37.448233 °	37.448233 °	
				-121.026521 °	-121.026521 °	
DWR ID	22086					
Comment Code						
Inspector Comment						
FS_ID:24435 DS_ID:22086 EP_NO: N/A Repair Type: Non-Urgent Crossing Status: Found UCIP Comments: 11/05/2013 Both pipe ends 70 ft off the levee center.Clearing and cleaning of inlet/outlet pipe needed. (P. Amatya - DWR UCIP) FIELD_STRUCT_DESC: 24-inch corrugated metal gravity drainage pipe through the levee, 12 feet below the crown. Flap gate on the waterside (WS) end. Concrete headwall on each end. Installed by USACE in 1961. [Additional Reference(s): DWR Levee Log, 1992. USACE San Joaquin O&M Manual 6, September 1961, (HLM 2.65)]. FS Date: 11/5/2013

LS view: concrete headwall with CMP 70 ft off the levee center.

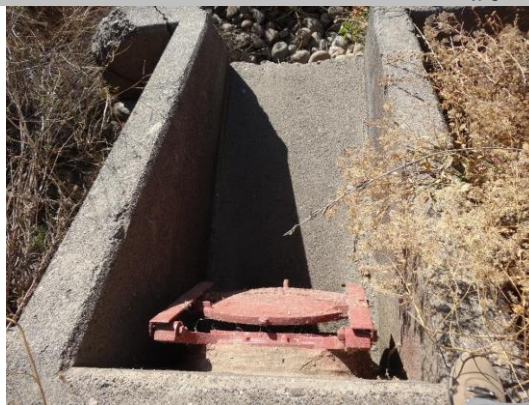
Photo 2 of 3 : UCIP_SP_2019_25023_45101.jpg

LM Start	2.68	Rating **	A/W	Issue No.	66
LM End	2.68	Issue Type +	Ma	Location *	
Category	Supplemental			GPS Latitude/Longitude	
				Start	End
Item	DWR UCIP LMA Responsibility			37.447475 °	37.447475 °
				-121.026017 °	-121.026017 °
DWR ID	22087				
Comment Code					
Inspector Comment					
FS_ID:25023 DS_ID:22087 EP_NO: N/A Repair Type: No Action Needed Crossing Status: Found UCIP Comments: 11/05/2013 Both pipe ends about 85 feet off the levee center. (P. Amatya - DWR UCIP) FIELD_STRUCT_DESC: 24-inch corrugated metal gravity drainage pipe through the levee, 20.3 feet below the crown. Flap gate on the waterside (WS) end. Concrete headwall on each end. Installed by USACE in 1961. [Additional Reference(s): DWR Levee Log, 1992. USACE San Joaquin O&M Manual 6, September 1961, (HLM 2.71)]. FS Date: 11/5/2013

WS view: pipe, flap gate, and concrete headwall on river bank.

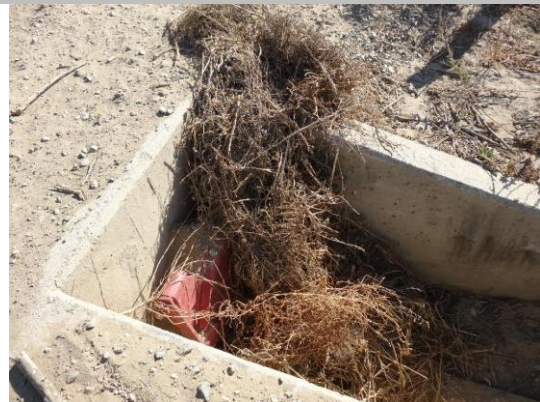
Photo 1 of 3 : UCIP_SP_2019_24443_43522.jpg

WS view: U typed concrete headwall on levee slope.

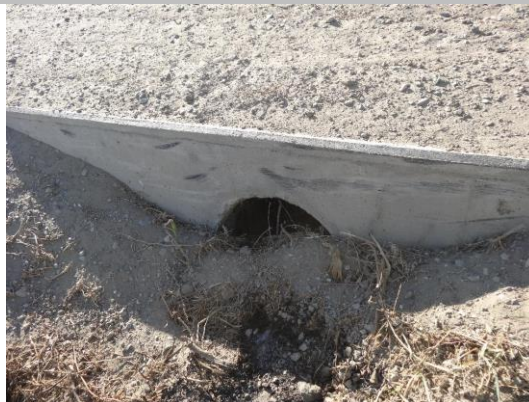
Photo 3 of 3 : UCIP_SP_2019_24443_43520.jpg

LM Start	2.93	Rating **	M	Issue No.	67 (cont)	
LM End	2.93	Issue Type +	Ma	Location *		
Category	Supplemental			GPS Latitude/Longitude		
				Start		End
Item	DWR UCIP LMA Responsibility			37.443871 °	37.443871 °	
				-121.025775 °	-121.025775 °	
DWR ID	22088					
Comment Code						
Inspector Comment						
FS_ID:24443 DS_ID:22088 EP_NO: N/A Repair Type: Non-Urgent Crossing Status: Found UCIP Comments: 11/05/2013 - clear and clean debris (P. Amatya - DWR UCIP) FIELD_STRUCT_DESC: *ABANDONED* 24-inch corrugated metal gravity drainage pipe through the levee, 9.5 feet below the crown. Flap gate on the waterside (WS) end. Pipe open on the landside (LS) end. Concrete headwall on each end. [Additional Reference(s): DWR Levee Log, 1992. USACE San Joaquin O&M Manual 6, September 1961, (HLM 2.97)]. FS Date: 11/5/2013

WS view: pipe, flap concrete headwall with soil debris blocking the inlet.

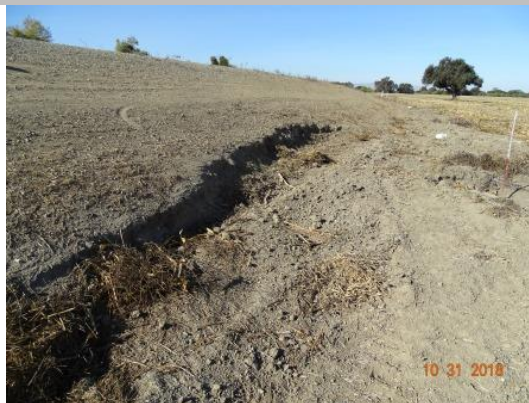
Photo 1 of 1 : SP_2019_RD2063_112_41_20190307_00007.jpg

View of agricultural equipment cutting into the levee slope. (Fall 2018)

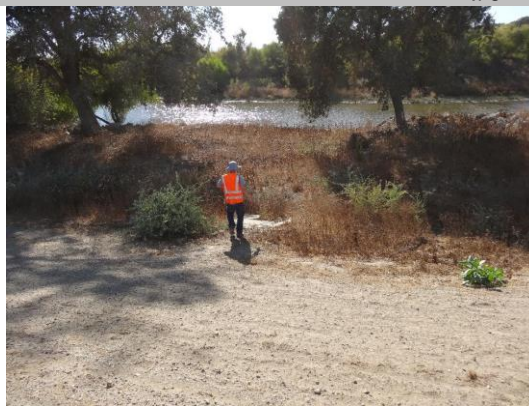
Photo 1 of 3 : UCIP_SP_2019_24469_43645.jpg

LM Start	3.29	Rating **	M	Issue No.	68	
LM End	3.29	Issue Type +	Ma	Location *		
Category	Supplemental			GPS Latitude/Longitude		
				Start		End
Item	DWR UCIP LMA Responsibility			37.441213 °		37.441213 °
				-121.021130 °		-121.021130 °
DWR ID	22089					
Comment Code						
Inspector Comment						
FS_ID:24469 DS_ID:22089 EP_NO: N/A Repair Type: Non-Urgent Crossing Status: Found UCIP Comments: 11/05/2013 - cleaning required in inlet pipe.- new flap gate (P. Amatya - DWR UCIP) FIELD_STRUCT_DESC: *ABANDONED* 24-inch corrugated metal gravity drainage pipe through the levee, 12.5 feet below the crown. Flap gate on the waterside (WS) end. Concrete headwall on each end. [Additional Reference(s): DWR Levee Log, 1992. USACE San Joaquin O&M Manual 6, September 1961, (HLM 3.33)]. FS Date: 11/5/2013

WS view: U typed concrete headwall on levee toe

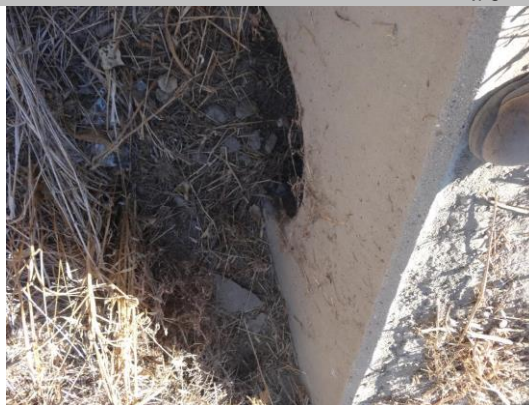
Photo 3 of 3 : UCIP_SP_2019_24469_43643.jpg

LM Start	3.29	Rating **	M	Issue No.	68 (cont)	
LM End	3.29	Issue Type +	Ma	Location *		
Category	Supplemental			GPS Latitude/Longitude		
				Start		End
Item	DWR UCIP LMA Responsibility			37.441213 °		37.441213 °
				-121.021130 °		-121.021130 °
DWR ID	22089					
Comment Code						
Inspector Comment						
FS_ID:24469 DS_ID:22089 EP_NO: N/A Repair Type: Non-Urgent Crossing Status: Found UCIP Comments: 11/05/2013 - cleaning required in inlet pipe.- new flap gate (P. Amatya - DWR UCIP) FIELD_STRUCT_DESC: *ABANDONED* 24-inch corrugated metal gravity drainage pipe through the levee, 12.5 feet below the crown. Flap gate on the waterside (WS) end. Concrete headwall on each end. [Additional Reference(s): DWR Levee Log, 1992. USACE San Joaquin O&M Manual 6, September 1961, (HLM 3.33)]. FS Date: 11/5/2013

LS view: CM pipe and concrete headwall on levee slope. Debris blocking inlet pipe.

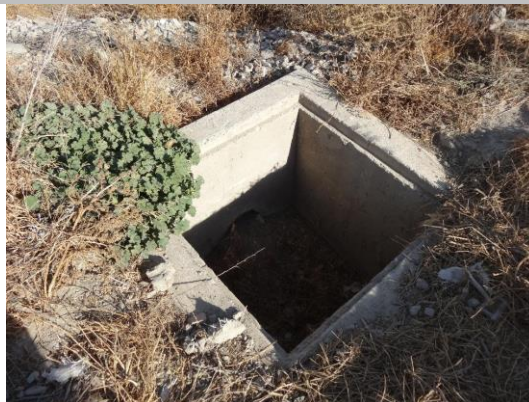
Photo 2 of 3 : UCIP_SP_2019_24485_43666.jpg

LS view: concrete drop inlet box on levee toe.

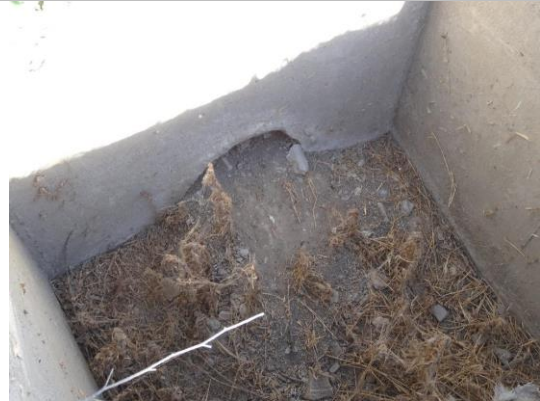
Photo 3 of 3 : UCIP_SP_2019_24485_43665.jpg

LS view: inside view of inlet box on levee toe. Debris blocking inlet pipe.

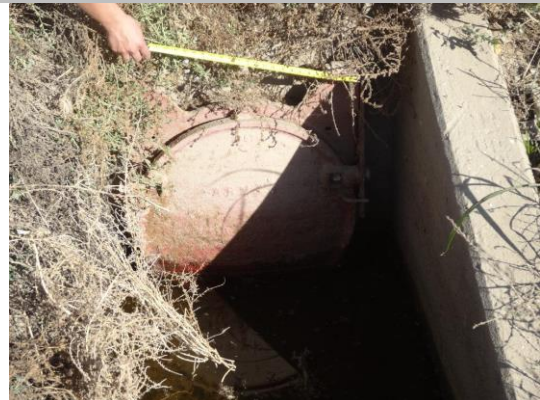
Photo 1 of 3 : UCIP_SP_2019_51821_43842.jpg

WS view: pipe, flap gate, and concrete headwall on drainage ditch.

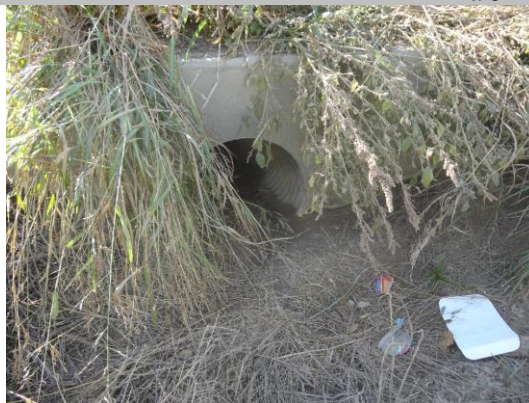
Photo 2 of 3 : UCIP_SP_2019_51821_43841.jpg

LS view: CM pipe and concrete headwall on levee toe.

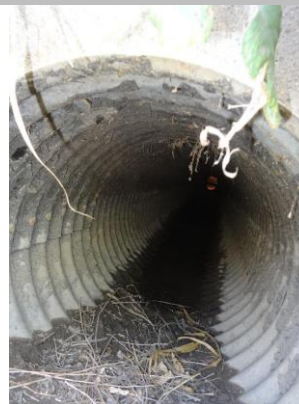
Photo 3 of 3 : UCIP_SP_2019_51821_43840.jpg

LS view: inside view of the CM pipe on levee toe.

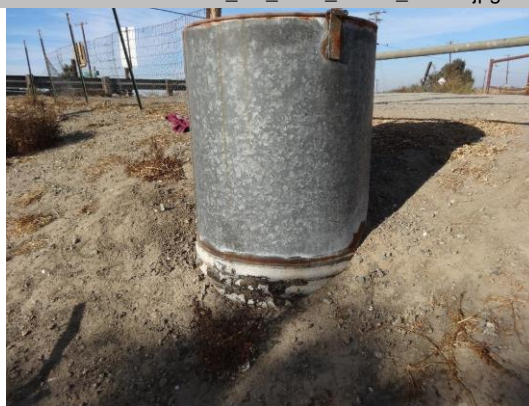
Photo 1 of 3 : UCIP_SP_2019_41746_43850.jpg

WS view: CMP riser on levee slope. Steel riser on top of CMP.

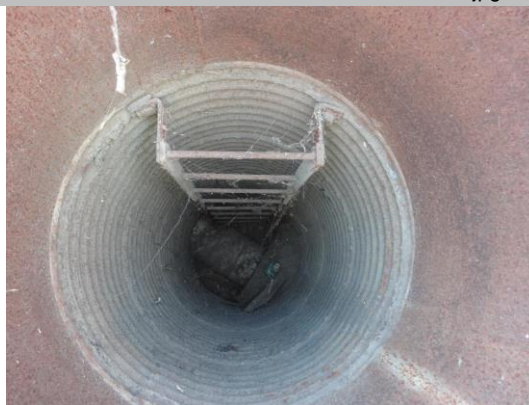
Photo 2 of 3 : UCIP_SP_2019_41746_43849.jpg

WS view: inside view of CMP riser on levee slope. Steel pipe and 24" CMP visible inside the riser.

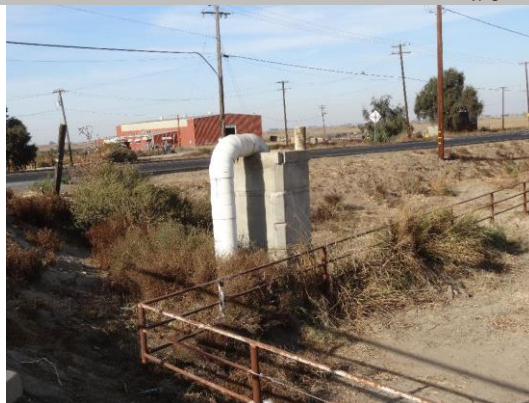
Photo 3 of 3 : UCIP_SP_2019_41746_43848.jpg

LS view: discharge pipe and concrete distribution box on levee toe.

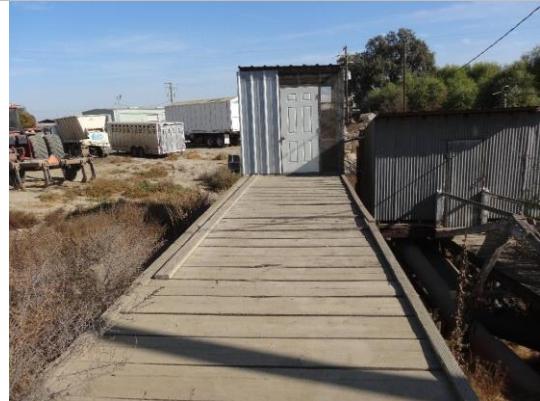
Photo 3 of 3 : UCIP_SP_2019_25025_45108.jpg

LS view: walkway to pump and pump house on levee slope.

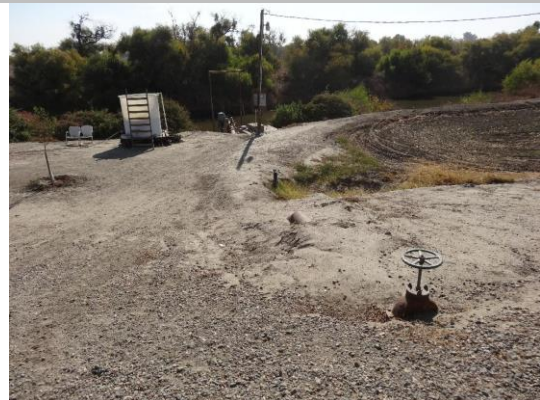
Photo 1 of 3 : UCIP_SP_2019_25028_45125.jpg

WS view: overview of waterside- gate valve and power pole on levee slope.

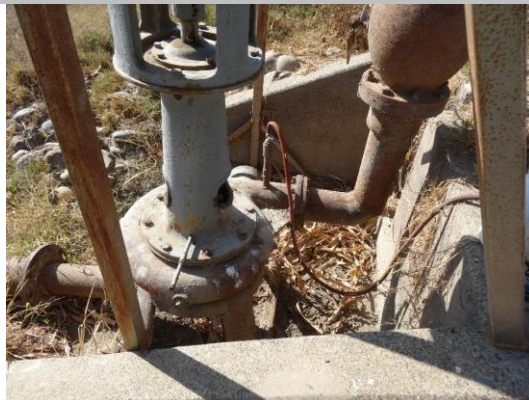
Photo 3 of 3 : UCIP_SP_2019_25028_45123.jpg

WS view: U type headwall and pump on river bank.

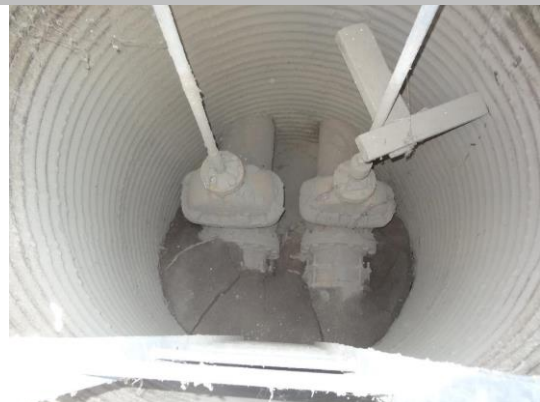
Photo 2 of 3 : UCIP_SP_2019_41669_45130.jpg

WS view: two gate valves inside CMP riser on levee slope.

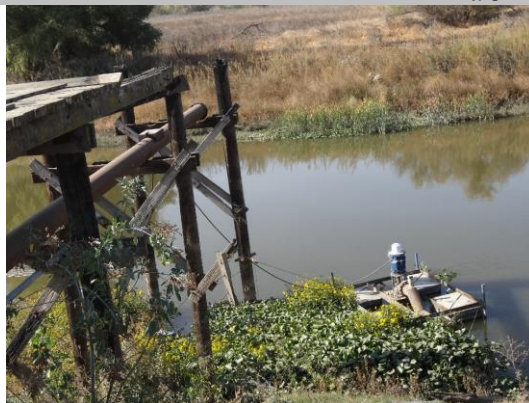
Photo 3 of 3 : UCIP_SP_2019_41669_45129.jpg

WS view: abandoned walkway, pipe (left) and pump on floating structure in the river.

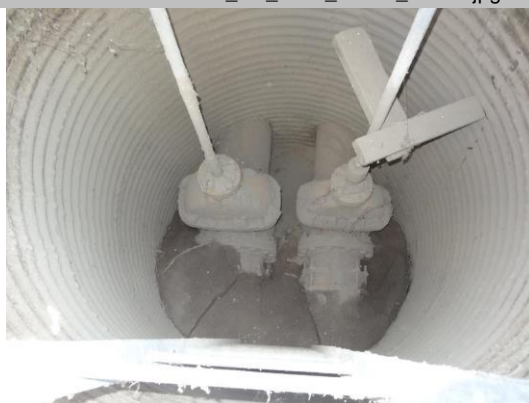
Photo 2 of 3 : UCIP_SP_2019_41670_43904.jpg

WS view: two gate valves inside CMP riser on levee slope.

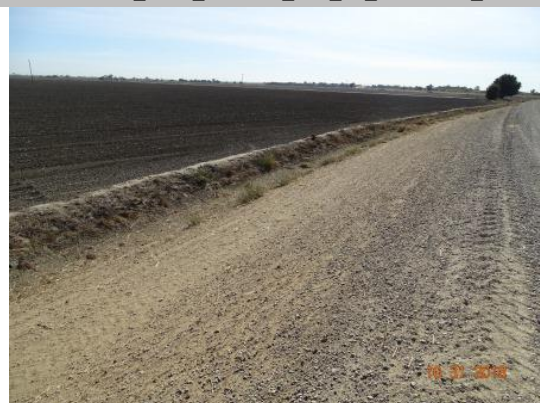
Photo 1 of 1 : SP_2019_RD2063_112_48_20190307_00012.jpg

View of ditch along levee toe. (Fall 2018)

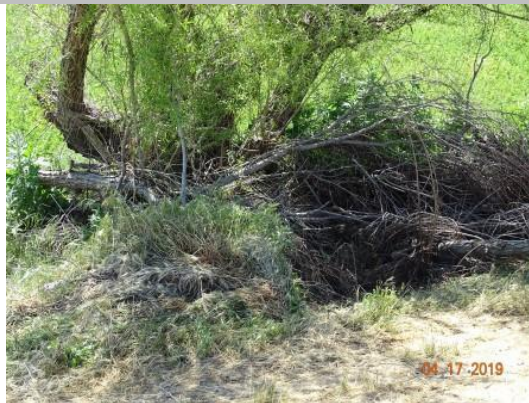
Photo 2 of 2 : SP_2019_RD2063_112_49_20190501_00113.jpg

View of prunings piled under a tree on landside toe. (Spring 2019)

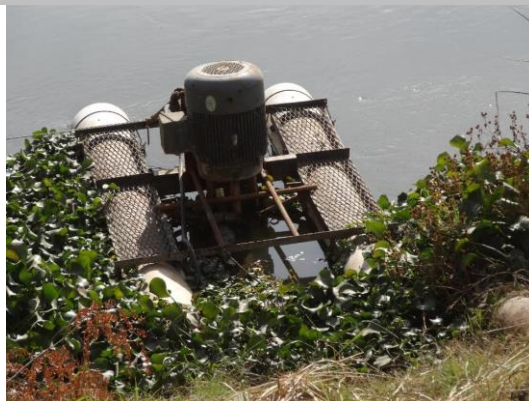
Photo 2 of 3 : UCIP_SP_2019_24628_43937.jpg

WS view: pump on floating structure in the stream.

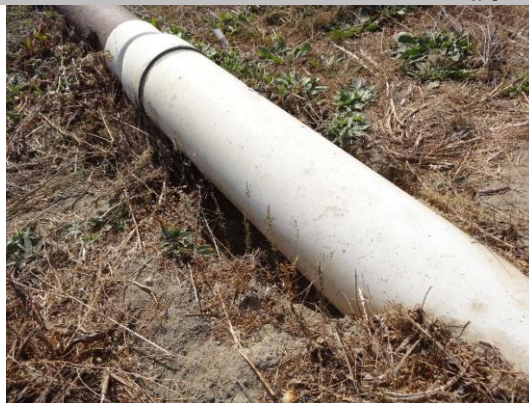
Photo 3 of 3 : UCIP_SP_2019_24628_43936.jpg

WS view: exposed pipe on levee slope. Erosion under the pipe.

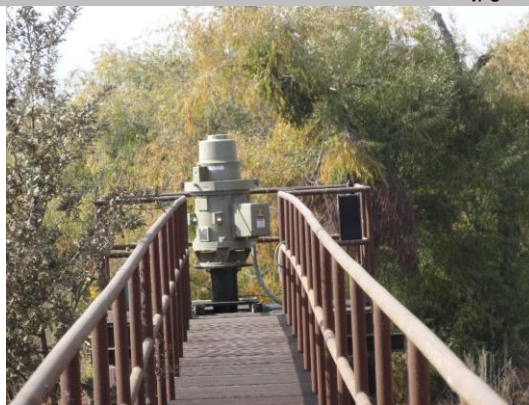
Photo 2 of 3 : UCIP_SP_2019_24629_43942.jpg

WS view: walkway to pump and pump on pile structure in the stream.

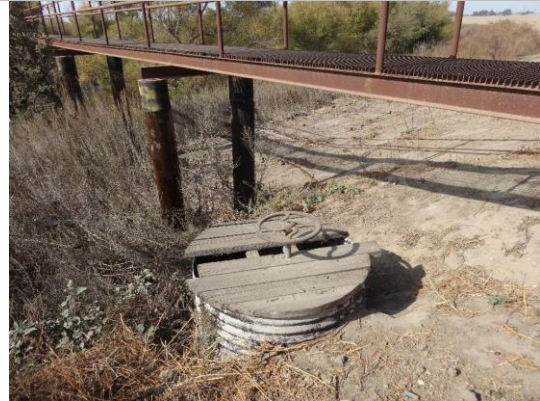
Photo 3 of 3 : UCIP_SP_2019_24629_43944.jpg

WS view: gate valve in CMP riser. Soil erosion around CMP riser.

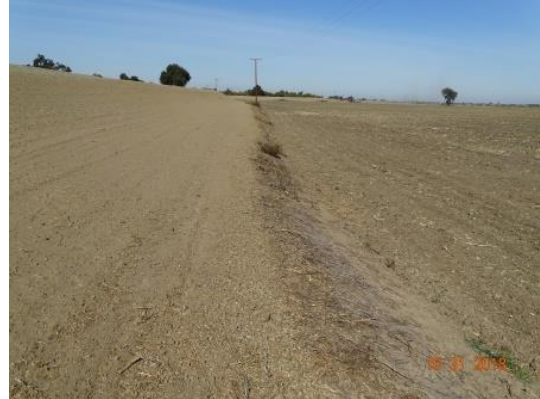
Photo 1 of 1 : SP_2019_RD2063_112_51_20190307_00014.jpg

View of cut into levee slope from agricultural equipment. (Fall 2018)

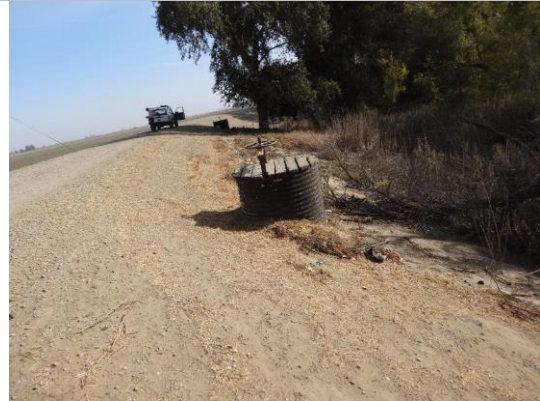
Photo 1 of 3 : UCIP_SP_2019_24632_43953.jpg

WS view: CMP riser on levee slope. No pipe visible on levee slope.

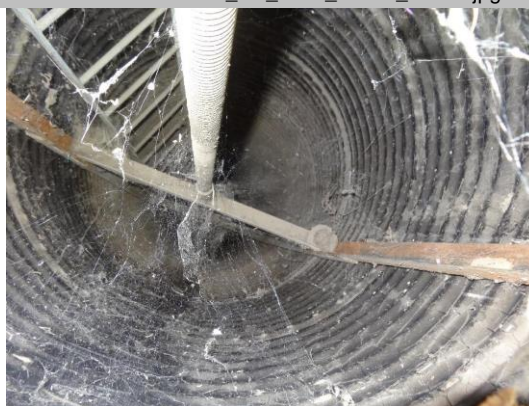
Photo 2 of 3 : UCIP_SP_2019_24632_43952.jpg

WS view: slide gate in CMP riser on levee slope.

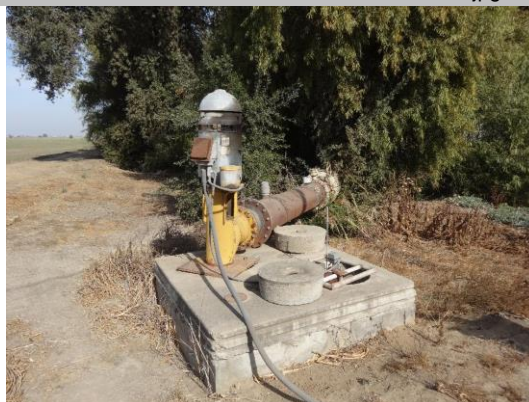
Photo 3 of 3 : UCIP_SP_2019_24632_43951.jpg

LS view: concrete distribution box on levee toe. Pump on the box discharges water into irrigation ditch.

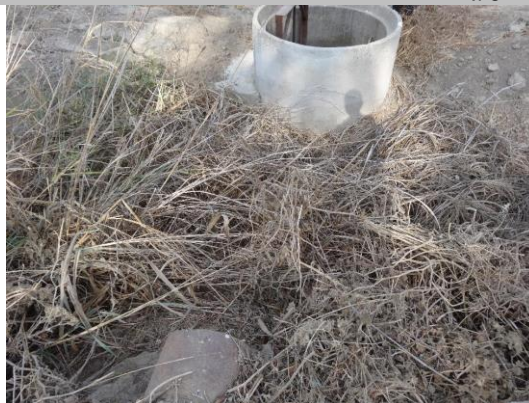
Photo 3 of 3 : UCIP_SP_2019_25031_45139.jpg

LS view: open-ended steel pipe on levee slope (bottom).

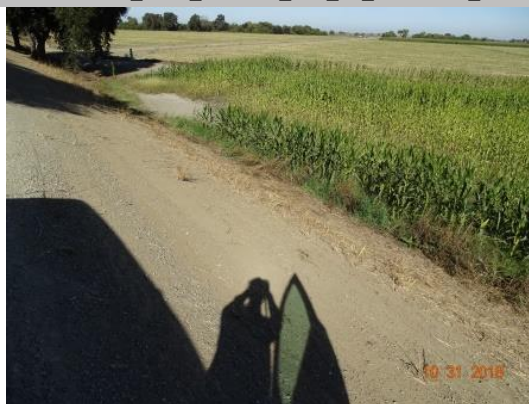
Photo 1 of 1 : SP_2019_RD2063_112_52_20190307_00015.jpg

View of corn planted in levee toe right up to the landside slope. (Fall 2018)

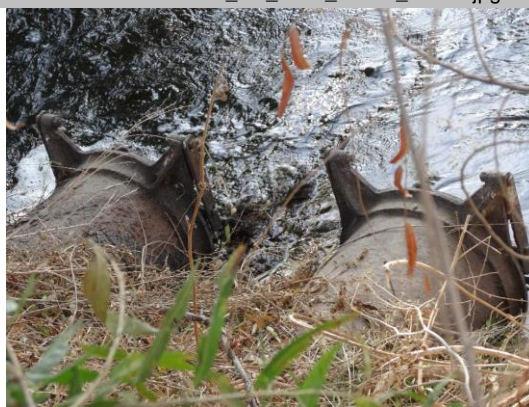
Photo 2 of 3 : UCIP_SP_2019_24651_44004.jpg

WS view: two flap gates on outfall pipe ends.

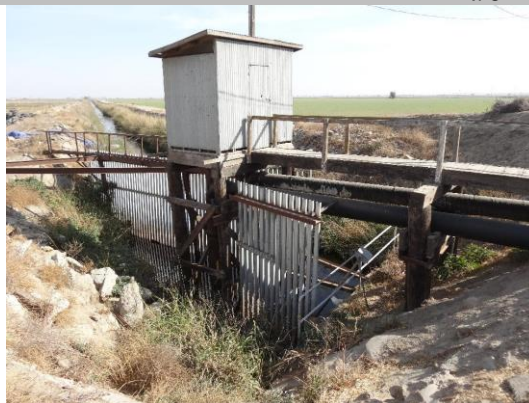
Photo 3 of 3 : UCIP_SP_2019_24651_44003.jpg

LS view: pipes under walkway to pump house.

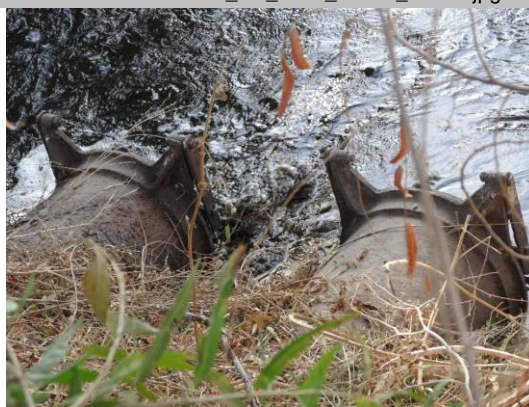
Photo 2 of 3 : UCIP_SP_2019_24652_44007.jpg

WS view: two flap gates on outfall pipe ends.

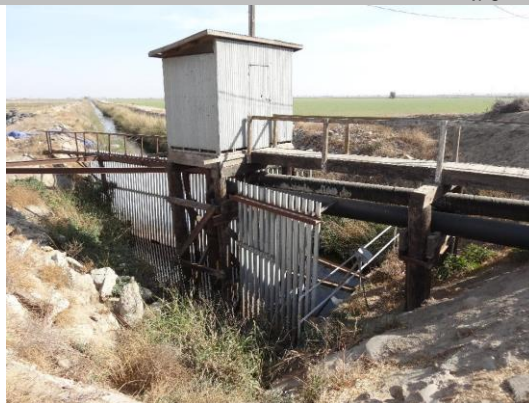
Photo 3 of 3 : UCIP_SP_2019_24652_44006.jpg

LS view: pipes under walkway to pump house.

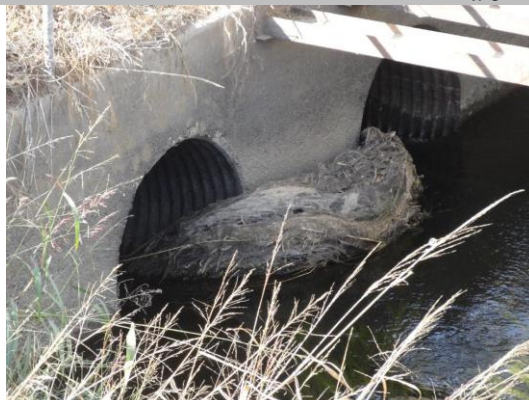
Photo 3 of 3 : UCIP_SP_2019_24650_44000.jpg

LS view: drainage pipes under walkway in drainage ditch.

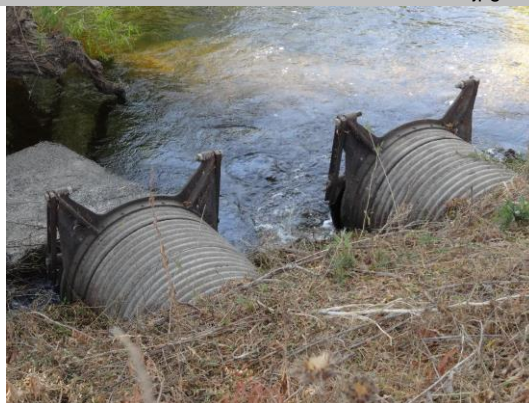
Photo 2 of 3 : UCIP_SP_2019_24636_43964.jpg

WS view: two flap gates on outfall pipe ends.

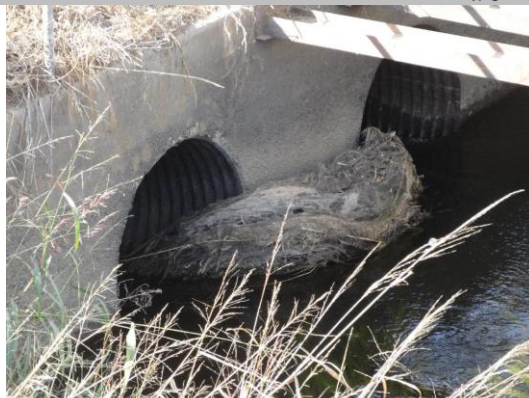
Photo 3 of 3 : UCIP_SP_2019_24636_43963.jpg

LS view: drainage pipes under walkway in drainage ditch.

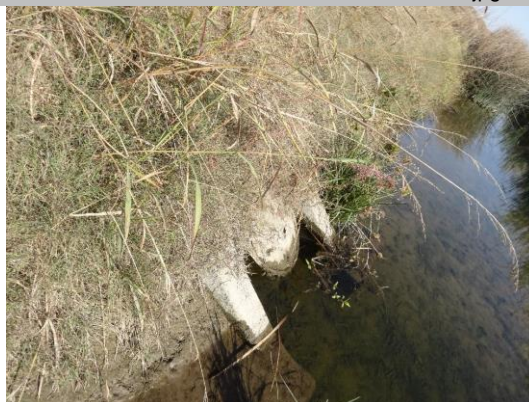
Photo 2 of 3 : UCIP_SP_2019_51825_43983.jpg

WS view: U type headwall and flap gate visible on the bank of the water channel.

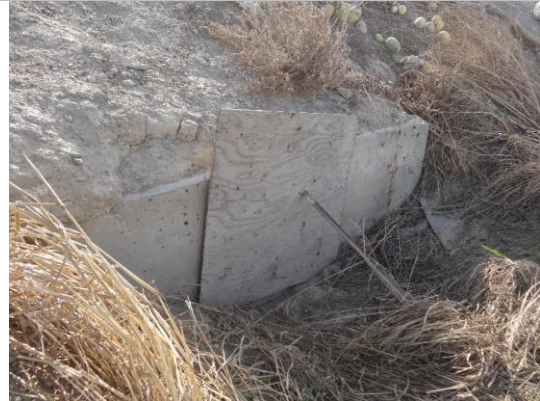
Photo 3 of 3 : UCIP_SP_2019_51825_43982.jpg

LS view: concrete headwall on levee end. Pipe opening blocked by plywood.

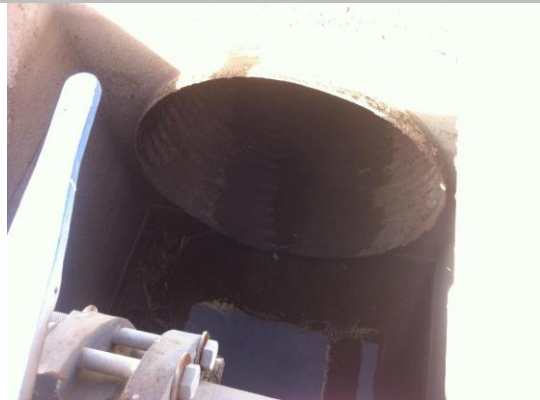
Photo 1 of 3 : UCIP_SP_2019_24644_43986.jpg

WS view: CM pipe on outlet concrete box.

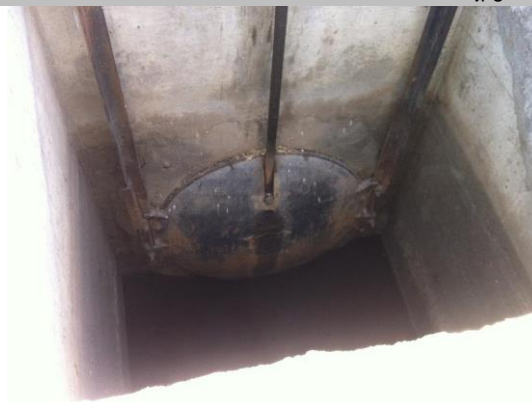
Photo 3 of 3 : UCIP_SP_2019_24644_43984.jpg

LS view: inside view of slide gate in concrete box.

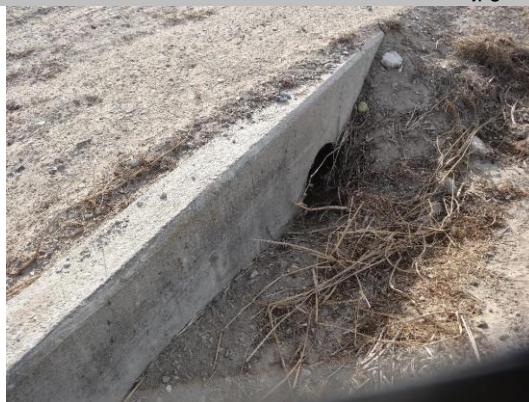
Photo 2 of 2 : UCIP_SP_2019_24645_43987.jpg

LS view: concrete headwall and partially blocked inlet opening.

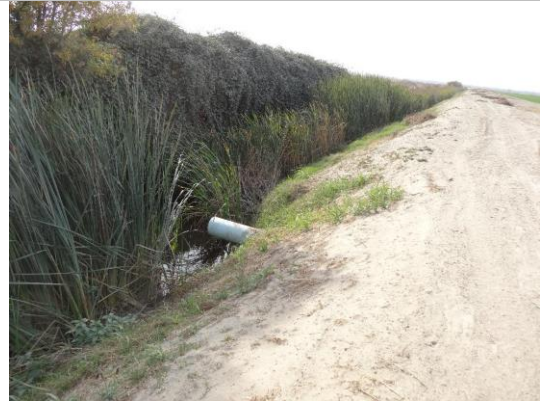
Photo 1 of 3 : UCIP_SP_2019_53095_43990.jpg

WS view: PVC pipe with open end on levee slope.

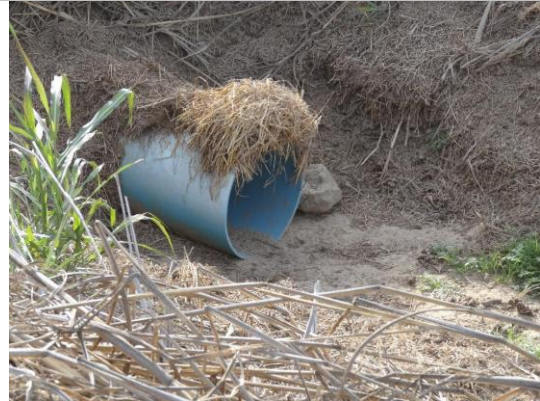
Photo 2 of 3 : UCIP_SP_2019_53095_43989.jpg

LS view: PVC pipe with open end on levee toe.

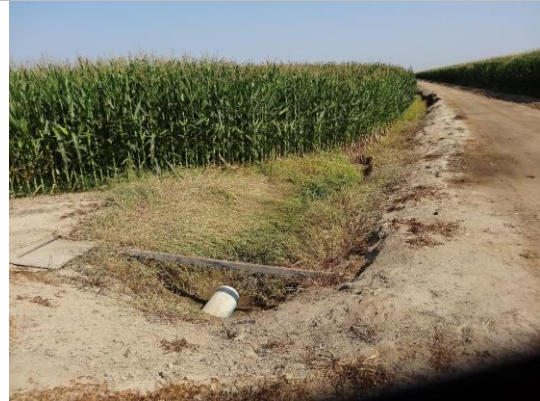
Photo 3 of 3 : UCIP_SP_2019_53095_76005.jpg

LS view of crossing

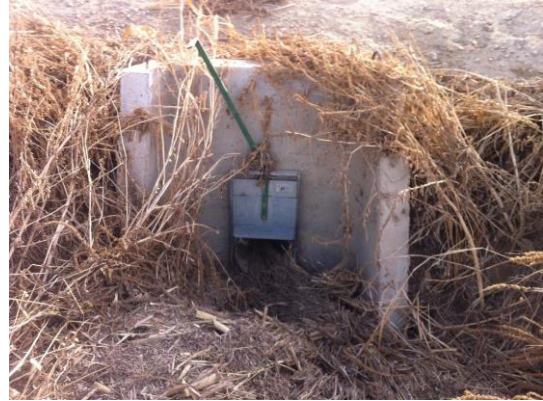
Photo 1 of 3 : UCIP_SP_2019_53096_43993.jpg

LS view: U type concrete headwall, slide gate, and pipe on levee toe.

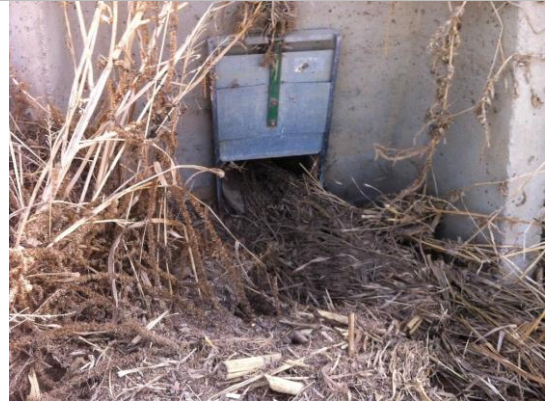
Photo 2 of 3 : UCIP_SP_2019_53096_43992.jpg

LS view: closer view of U type concrete headwall, slide gate, and pipe on levee toe.

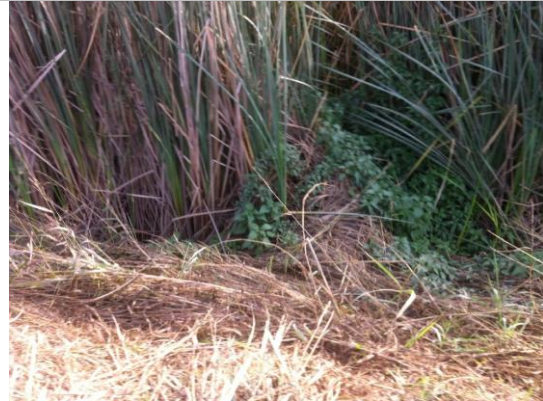
Photo 3 of 3 : UCIP_SP_2019_53096_43991.jpg

WS view: dense vegetation, no pipe visible.

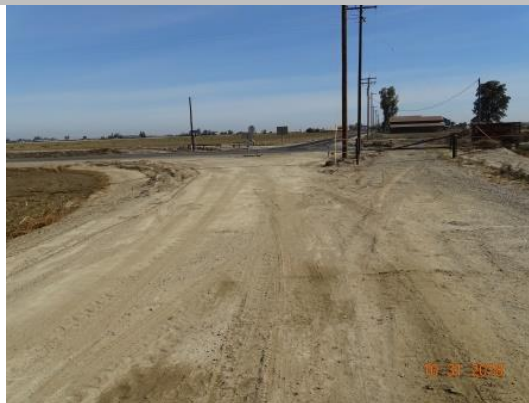
Photo 1 of 1 : SP_2019_RD2063_112_54_20190307_00016.jpg

View of unpermitted ramp coming off of street. (Fall 2018)
